Subject: Near Miss Report - Illegal Fuel Transporting Vehicles

NEAR MISS REPORT

NEAR MISS – Illegal Fuel Transporting Vehicles

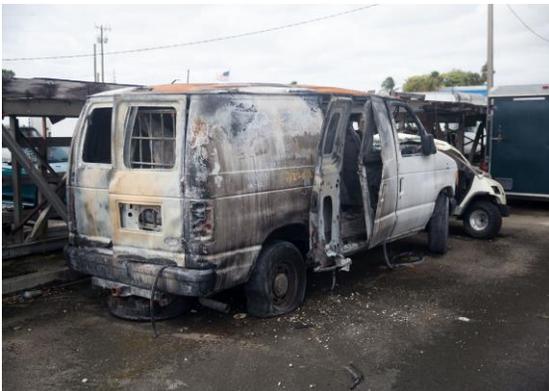
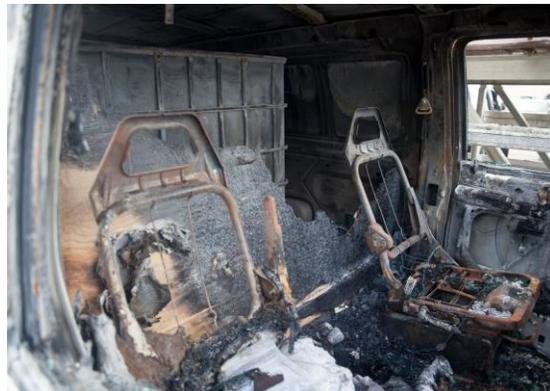
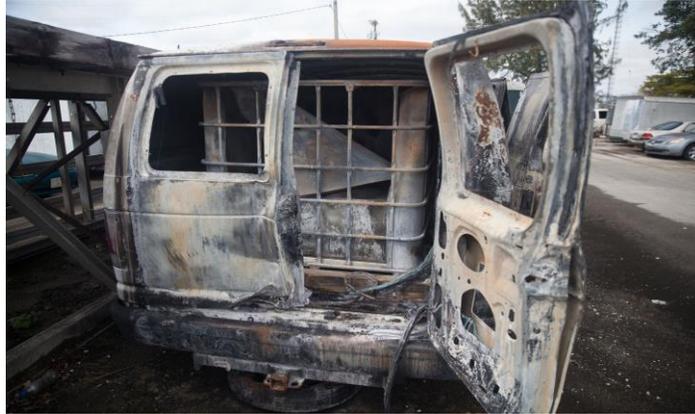
While the crew began stretching the hose the company officer began a counter clockwise 360 size up of the van. During his 360, he noticed that he could not see into the rear windows of the van because they appeared to be painted black. The officer rejoined his crew and they began to attack the fire showing from the front windows. Once the fire conditions began to improve, the crew attempted to open the side cargo doors with hand tools. Although there was no indication from the outside that the doors were fortified on the inside, they had no success forcing them conventionally with hand tools. Next they attempted to use a rotary saw with a metal cutting blade and about 30 seconds into using the saw the fire flashed. At that point the officer requested a second hand line to attack the fire from the rear. He also ordered a different crew on scene to force the rear doors with hand tools but they were unsuccessful. While they were attempting to force the rear doors the fire flashed again, nearly engulfing the two firefighters at the rear doors of the van. The crews continued to battle a fire that would show improved conditions but then would suddenly increase in size and intensity. They continued to attack the fire and protect exposures with foam and eventually extinguished the fire with dry chemical supplied by an airport foam truck.

There was nothing “typical” or “routine” about this van fire; it was carrying an unknown amount of gasoline in a “bladder”; in this case, a large plastic container designed to contain soap or other non-combustible liquids. According to Miami-Dade police, the transport of large quantities of stolen gasoline and diesel fuel in illegal bladder vehicles is increasing in our area. Please [click here](#) to watch a short video from Miami-Dade Detective Marcos Rodriguez about illegal fuel transporting vehicles.

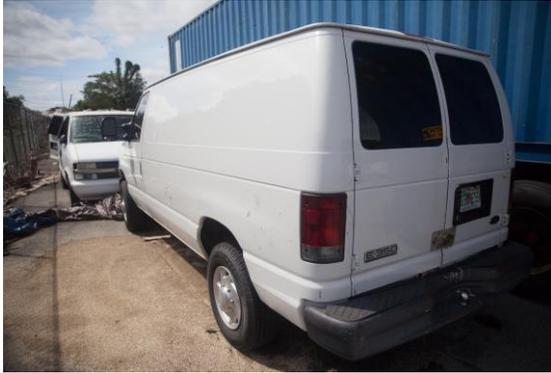
Cargo Van:

blacked out (painted windows) windows, reinforced rear and side doors

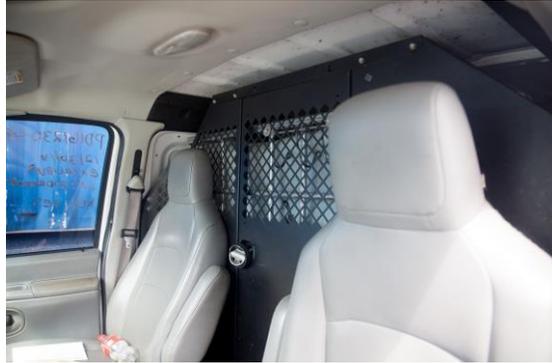
Rear access partition to limit view and access to rear

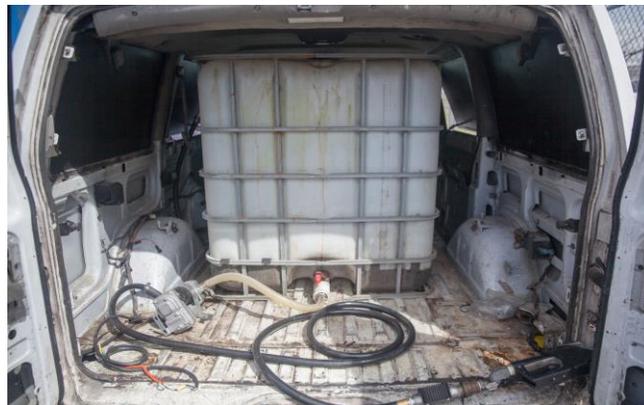
Plastic container was intended for soap or other non-flammable liquid. Note the hoses and wires leading to the transfer pump.

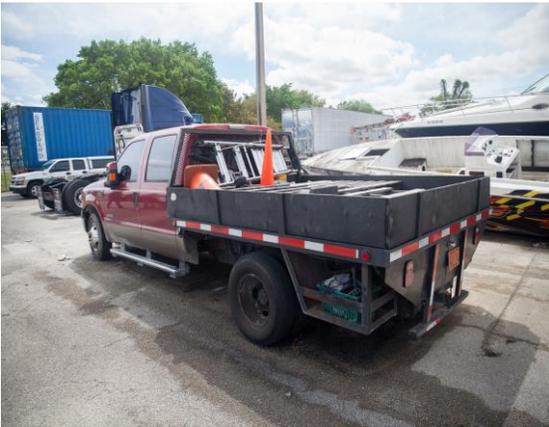
Flatbed Truck:

Tank concealed in bed of truck. Items on top of cargo bed to disguise the tank

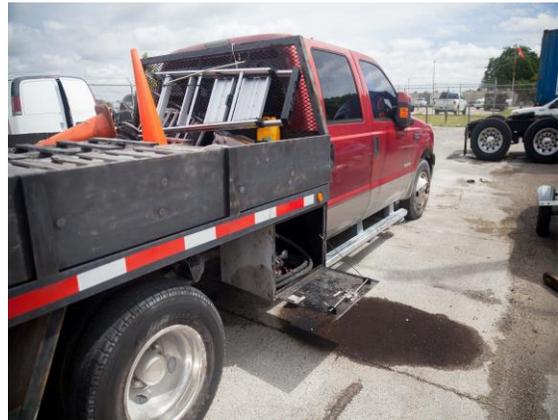
Fill hose with pump in right side box

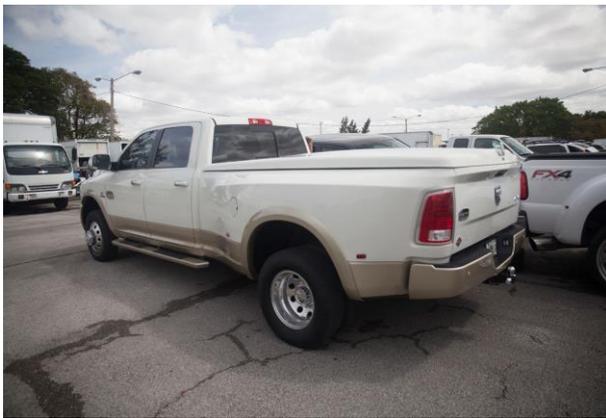
Pickup Truck:

Bed topper or other objects covering tank in bed of truck

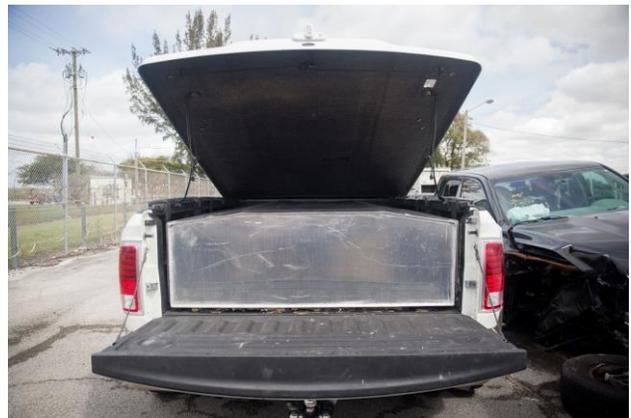
Inverted boat fuel tank

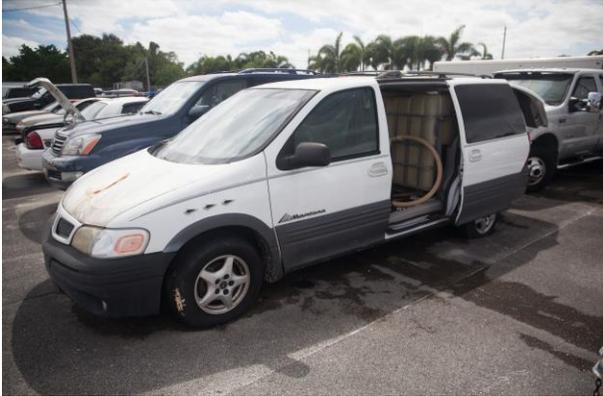
Minivan:

Dark or painted rear windows to conceal bladder tank

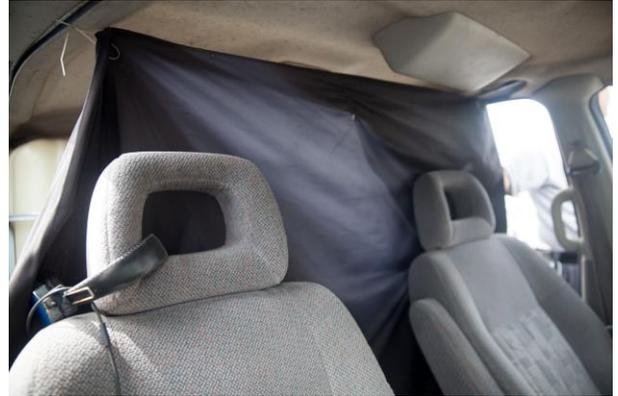
Cover to limit visibility to rear

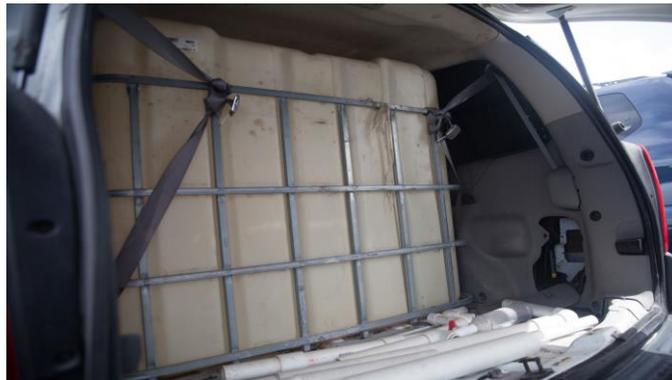
Hoses, pump, and equipment

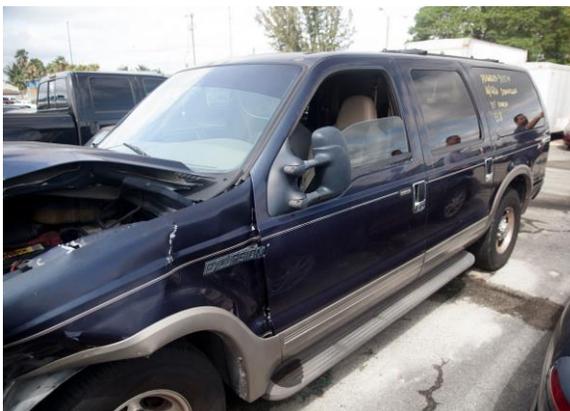
SUV:

SUV with blacked out windows

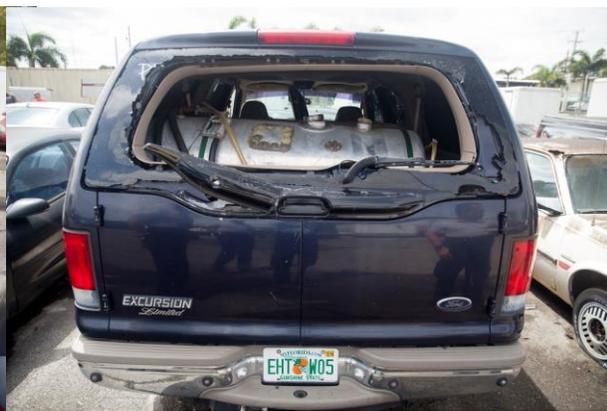
Large illegal tank in the rear of the SUV

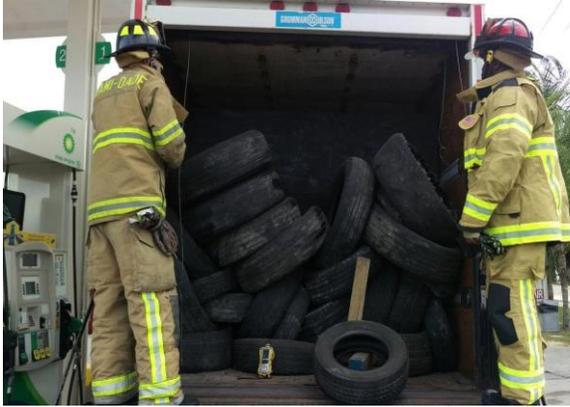
Tires stacked in front of partition

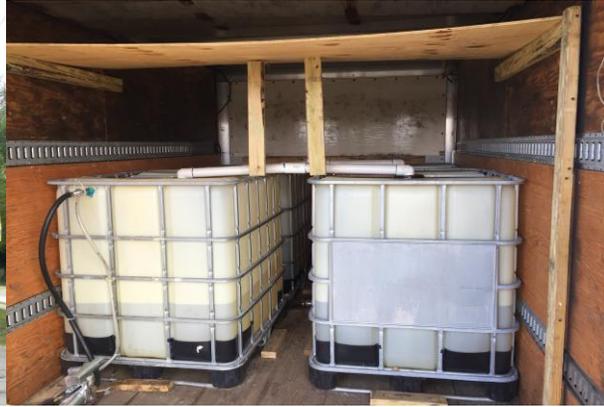
4 tanks hidden behind tires and partition
